LEAD-BASED PAINT INSPECTION REPORT

The Town of Pawling
160 Charles Coleman Blvd.
Pawling, NY 12564

Murrow Park
Pawling, NY 12564

Project # EL09L-17

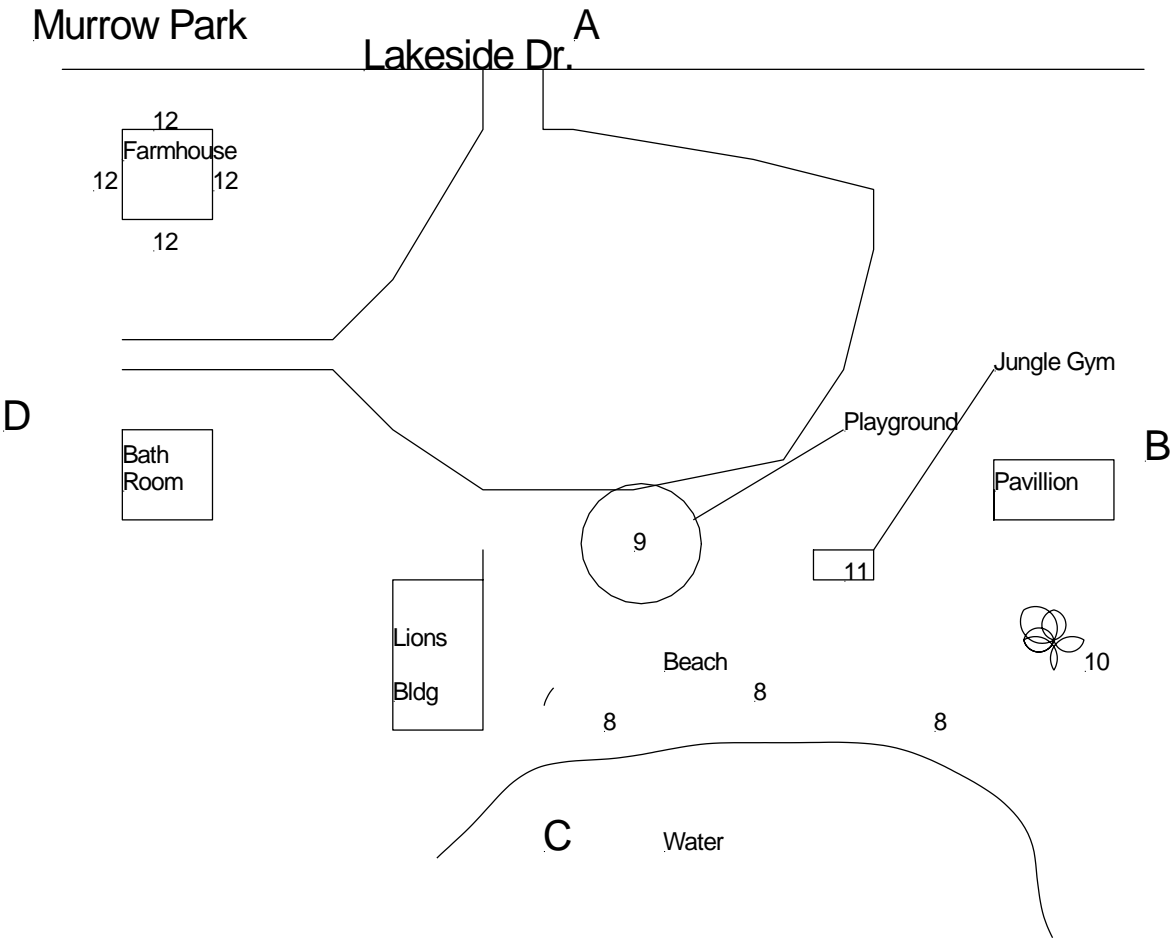
LOCATION DRAWINGS

The numbers indicate soil sample locations.

The purpose of this limited inspection is to identify and assess select exterior painted components at the subject property. The intent of this inspection was to ascertain the presence of lead-based paint above specified regulatory action levels. If lead-based paint was found, the inspection would identify types of architectural components and their respective lead concentrations in such a manner that this report could be used as a basis for subsequent abatement activity. For the purpose of this lead based paint inspection, “Wall A” represents the side of the buildings or structures facing Lakeside Dr. “Wall B”, “Wall C” and “Wall D” are the walls or sides clockwise from “Wall A” respectively. Please refer to the attached drawing.
